Manhole Inspection Summary

Manhole # S57C__010MH

Insp Date: **6/25/08 1:30 PM**

Location Address: **rear 100 n kresson st**

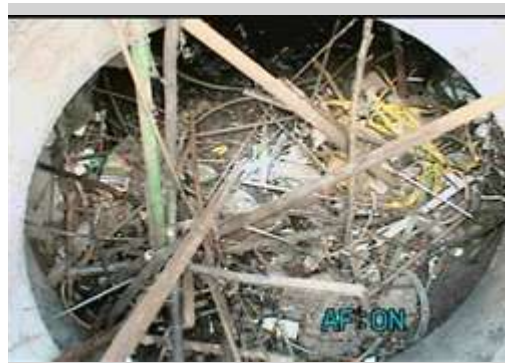
Top View

Condition: ☐ Sound ☐ Cracked ☐ Root Intrusion ☐ Deteriorated ☐ Leaks ☒ **Debris**

top view & channel debris

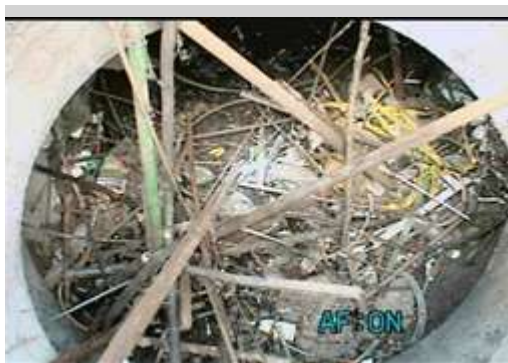
Defect 3

channel debris

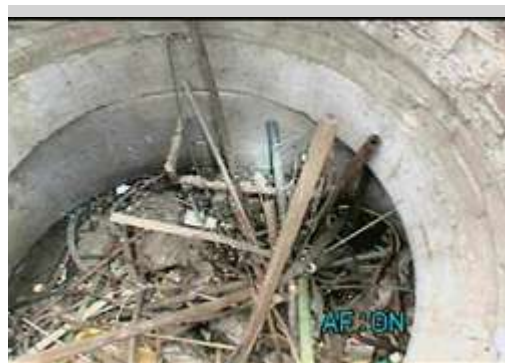
Defect 2

Steps Count: **1** Missing: **0** ☒ **Corroded**

debris, step

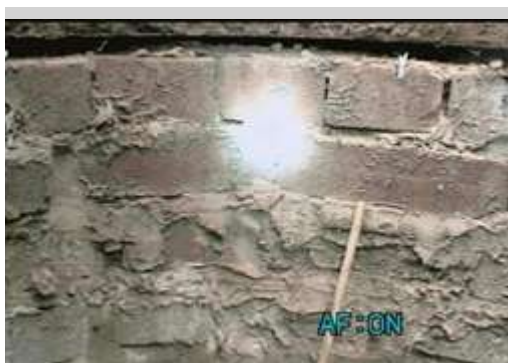
Defect 1

Chimney / Frame Adjustment ☒ Exists Material: **Brick and Concrete** ☐ Parged Height: **5** (in.)

Condition: ☐ Sound ☐ Cracked ☐ Root Intrusion ☐ Loose Brick ☒ **Deteriorated**

Infiltration: ☐ None ☐ Joint ☐ Cracks ☒ **Mortar** ☐ Roots ☐ Wall

frame adj

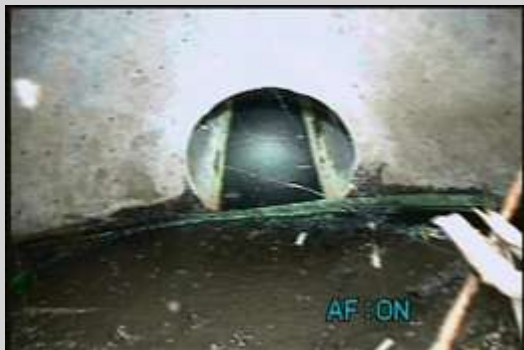
12 O'Clock Outflow

Comments **Pipe at 12 is going towards e fayette st**

8 in. Circular Gravity Sewer
Pipe Out @ 12 O'Clock
